Debris/Ice/TPS Assessment and Integrated Photographic Analysis of Shuttle Mission STS-68

**DEBRIS/ICE/TPS ASSESSMENT
AND
INTEGRATED PHOTOGRAPHIC ANALYSIS
OF
SHUTTLE MISSION STS-68**

30 September 1994

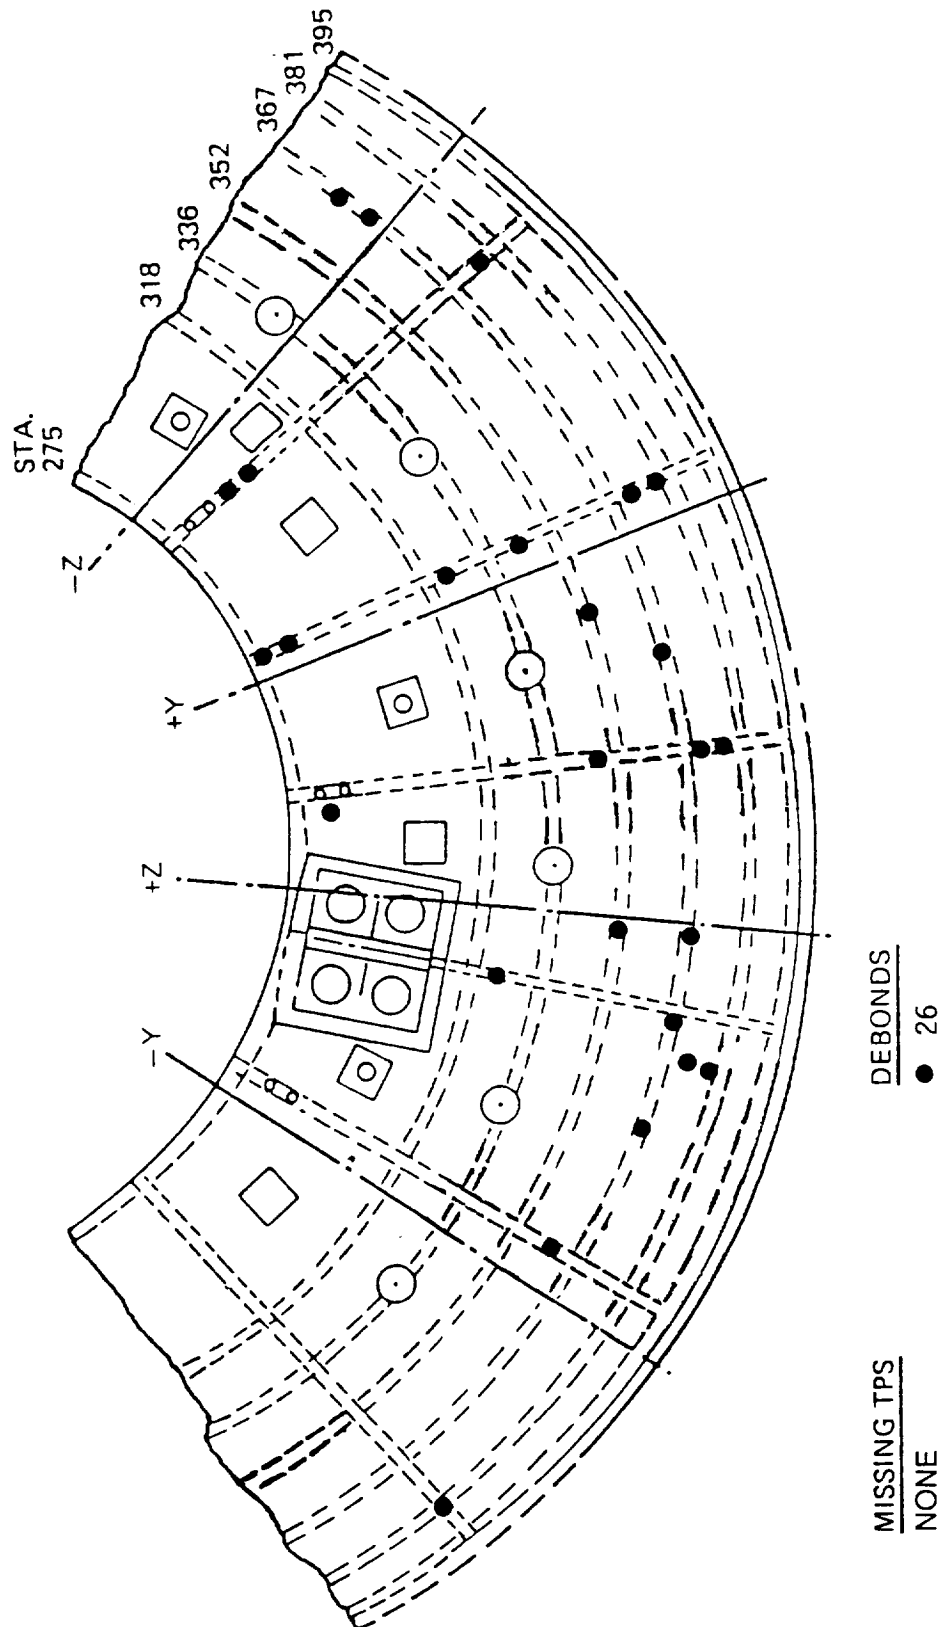
Figure 1 : RH SRB Frustum

The RH frustum was missing no TPS but had 26 debonds over fasteners (Figure 1). Hypalon paint was blistered/missing along the 395 ring frame where BTA had been applied. Some of the underlying BTA was sooted. The BSM aero heat shield covers had locked in the fully opened position.

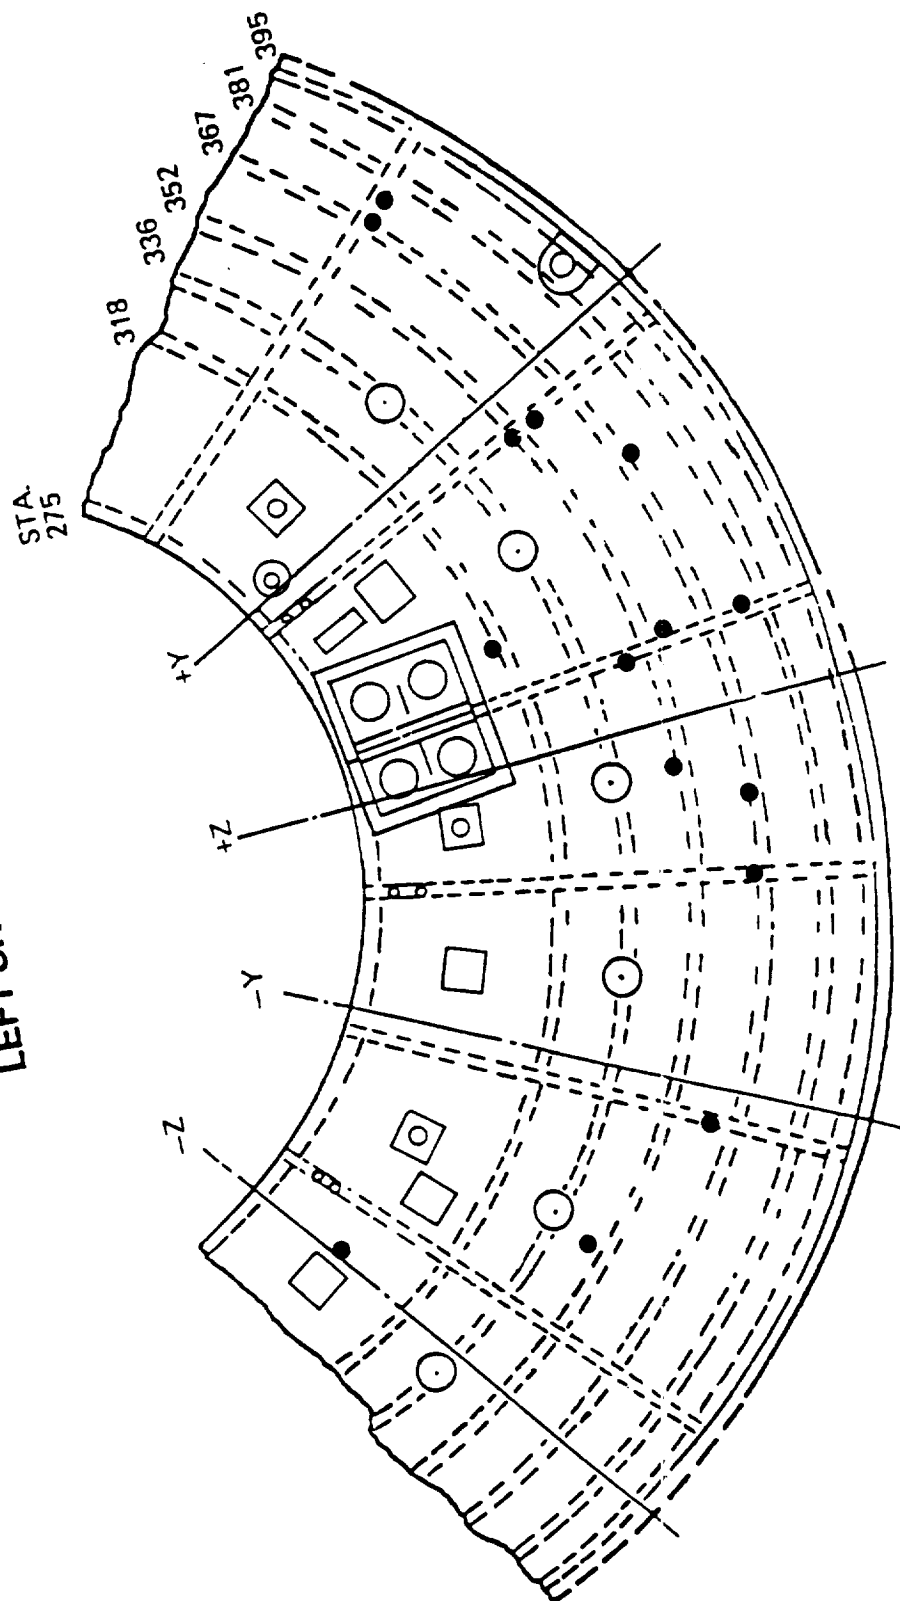
DEBONDS
● 15

MISSING TPS
NONE

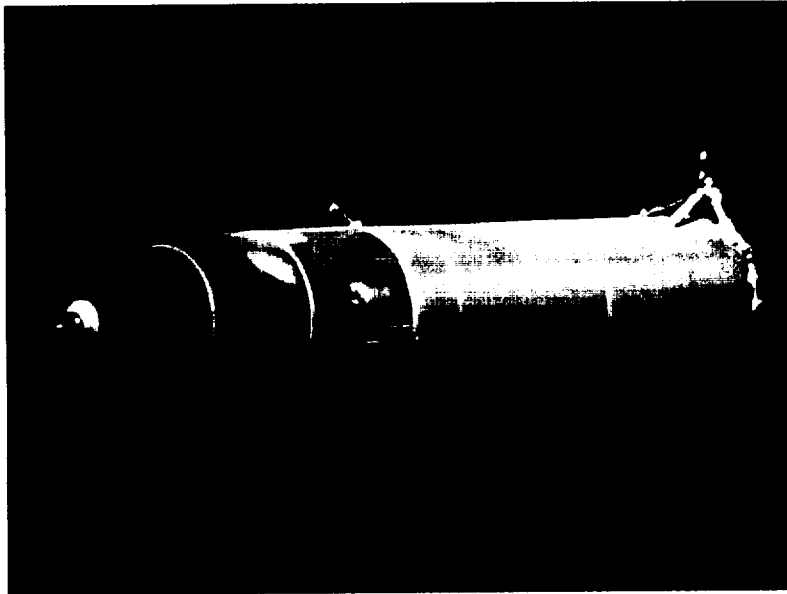
-Z area of the tank. Two divots were also observed on the LH2 tank acreage near the -Y axis. A picture from the hand-held camera is provided as figure 3. A divot located along a stringer on the intertank was observed from the umbilical well cameras. This divot is in line with the +Z axis.

Figure 3 Film frame from hand-held camera

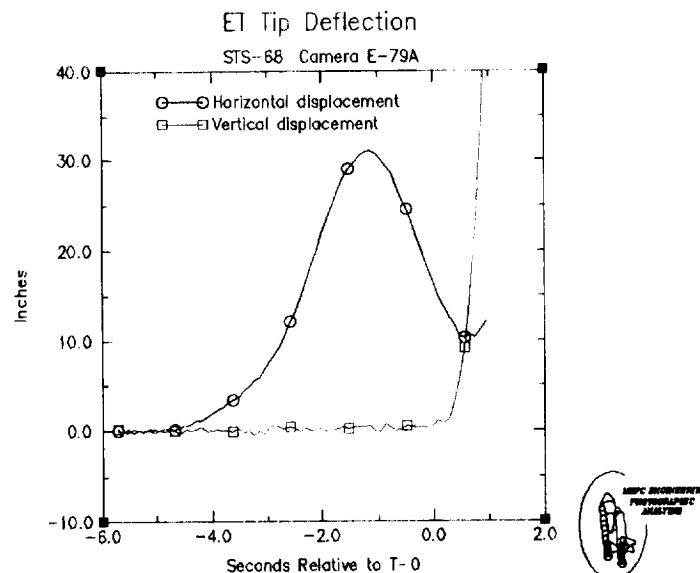
Maximum ET tip deflection for this mission was determined to be approximately 31 inches. Figure 7 is a data plot showing the measured motion of the ET tip in both the horizontal and vertical directions. A positive horizontal displacement represents motion in the -Z direction. These data were derived from film camera E-79A.

Figure 7 ET Tip Deflection
